Catheterography: a simple technique for the diagnosis of poor peritoneal dialysis catheter functioning

Nefrologia 2012;32(5):677-8

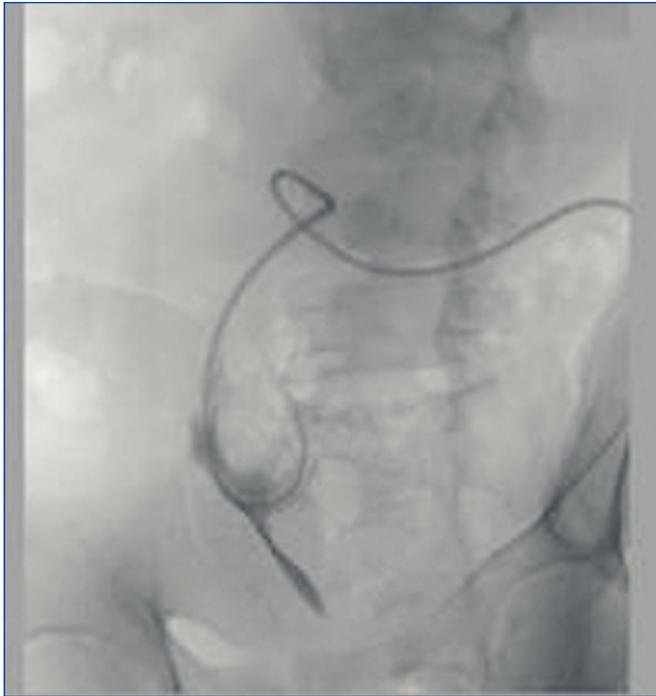
Figure 1. Case 1.

Case 1. 56-year-old; 4 months on CAPD without issues. Episode of severe peritonitis due to an anaerobic bacterial infection. Once recovered, the patient was started on APD. After several weeks, the patient complains of not being able to sleep due to multiple alarms. The treatment regime is evaluated, and a major drainage difficulty is revealed. A simple abdominal x-ray reveals no important findings; the tip of the catheter is observed in the pelvis. A catheterography is administered, which reveals a large loop in the catheter. The situation is resolved through the use of a guide and increased laxative treatment (Figure 1).

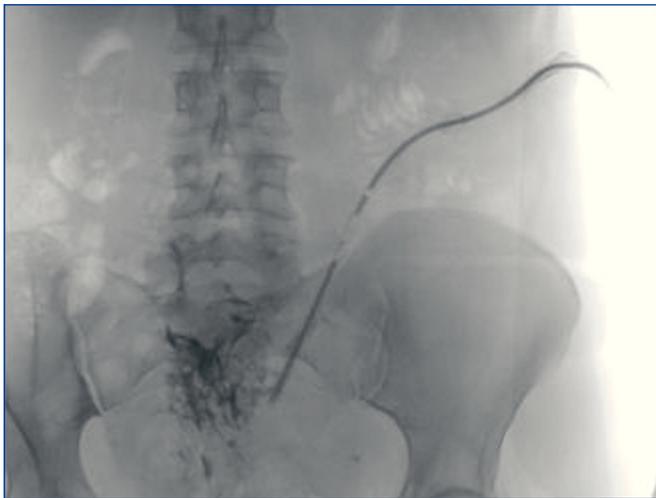
Figure 2. Case 2.

Case 2. 65-year-old woman who started PD after a second transplant. During surgery for the catheter placement, multiple intestinal adhesions are freed. From the start, infusion went without difficulty, but drainage was impossible. A catheterography confirmed the suspicion of

entrapment; the catheter was then removed through surgery (Figure 2).

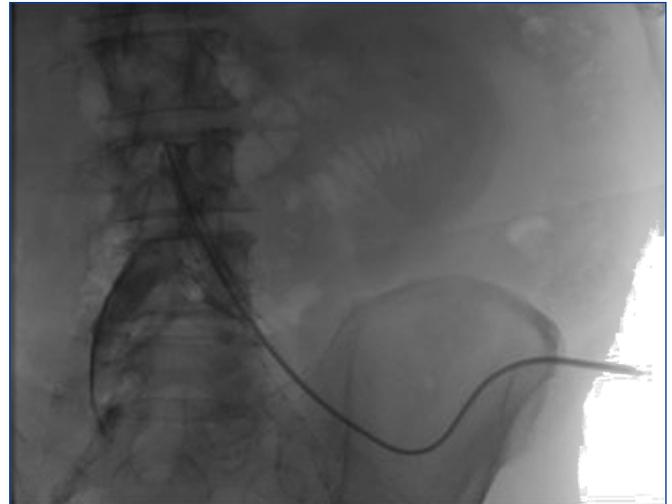
Figure 3. Case 3.

Case 3. 72-year-old patient, who after 15 months on APD started to have issues with drainage, despite laxative use. The catheter tip was found in the epigastrium, and was relocated using a guide (Figure 3).
